Renovation indoor swimming pool, Burgdorf

2010

The project

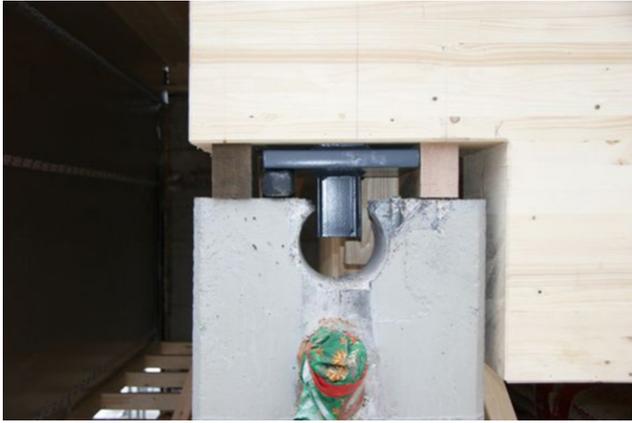
Support before casting

Twin beams were installed on both sides of the existing beams and braced with additional doublers on both sides of the concrete columns. A Lignotrend acoustic ceiling was installed under the new rafter purlins. The indoor swimming pool The construction method of the indoor swimming pool and the size of the girders did not allow renovation from below. Therefore, a different approach was chosen for the indoor swimming pool. The existing supporting structure, including the roofing, was removed section by section and completely replaced. Here, too, glulam beams were used. The increased risk of corrosion of metal parts necessitates the use of highly corrosion-resistant and correspondingly expensive steel grades. To take account of this, both main and secondary beams were directly supported throughout the building, without any statically loaded steel parts. Special care was taken to seal the roof, exterior walls and connections.

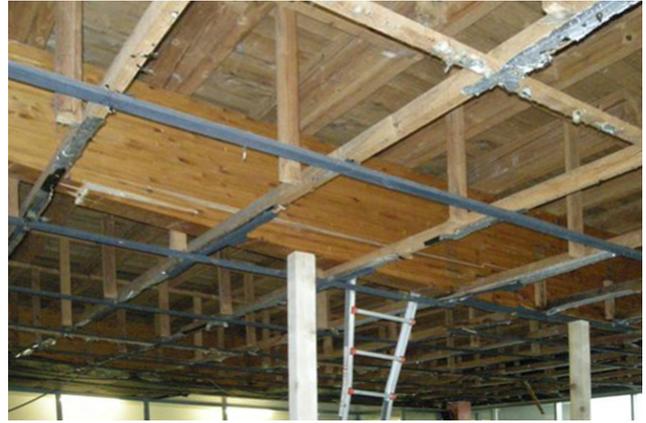
Existing supports

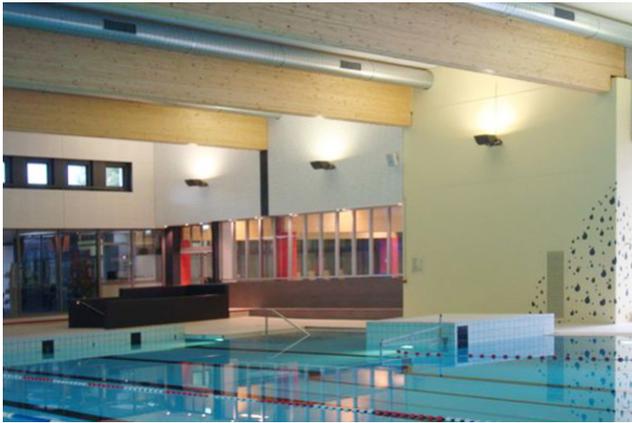
Interior view against learning pool

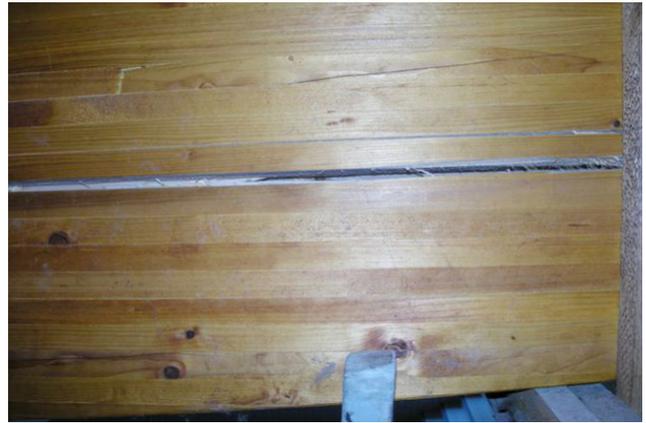
During the inspection of a steel beam, cracks were found in the adjacent wooden beams. Not nice conditions for a well-attended indoor swimming pool! But Timbatec had the solution.

Cracks with consequences: The discovery of the cracks in the primary beams were the trigger for the immediate closure of the indoor pool and the learning pool. Timbatec's proposal to first make the small learning pool usable in order to be able to resume the existing swimming and water courses as soon as possible met with approval. During the renovation of the learning pool, the renovation of the indoor pool roof was planned and prepared. The renovation of the learning pool took three months, while the renovation of the indoor pool took another four months. The learning pool: The new structure was inserted into the existing one from below in order to preserve the recently constructed flat roof insulation and waterproofing. The structure was made stronger for a possible single-story addition.

Cracks
