# Pedestrian footbridge Dählhölzli Zoo, Bern

2000

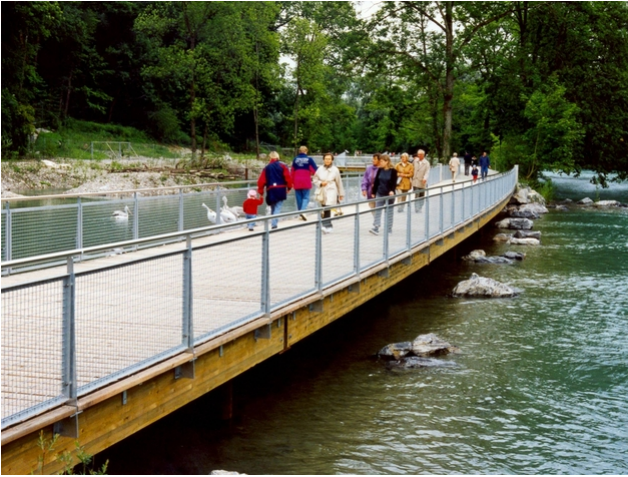
Pedestrian path in operation

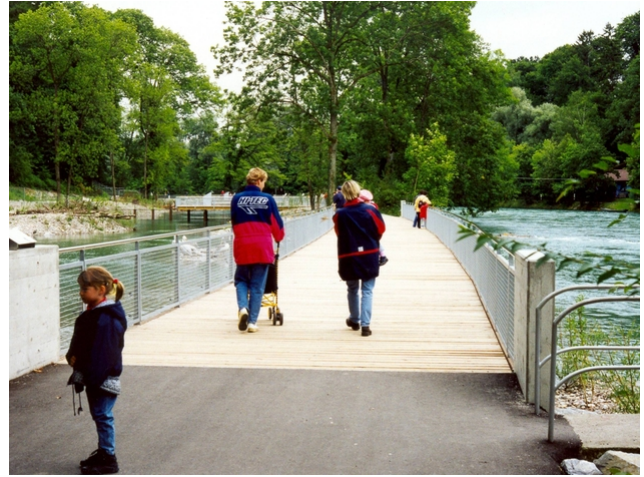
The beginning of the bridge

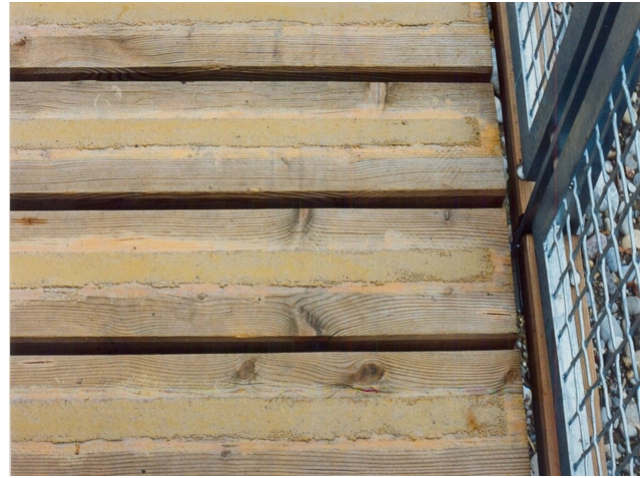
Bridge detail

In order to protect the substructure from further flood damage, it was concreted as supports and, at the jetty - platform connection, as a slab. The glulam beams (14 x 43 cm) were attached to these at a center distance of 59 cm by means of steel angles. The floor is covered with 50 mm larch planks, which have been provided with a non-slip layer in the middle of the upper side. The whole construction is surrounded with air on all sides, so that it can dry again after each rain.
